DEPARTMENT OF THE INTERIOR
UNITED STATES GEOLOGICAL SURVEY

THE
SAN FRANCISCO EARTHQUAKE AND FIRE

APRIL 18, 1906

AND THEIR EFFECTS ON STRUCTURES AND
STRUCTURAL MATERIALS

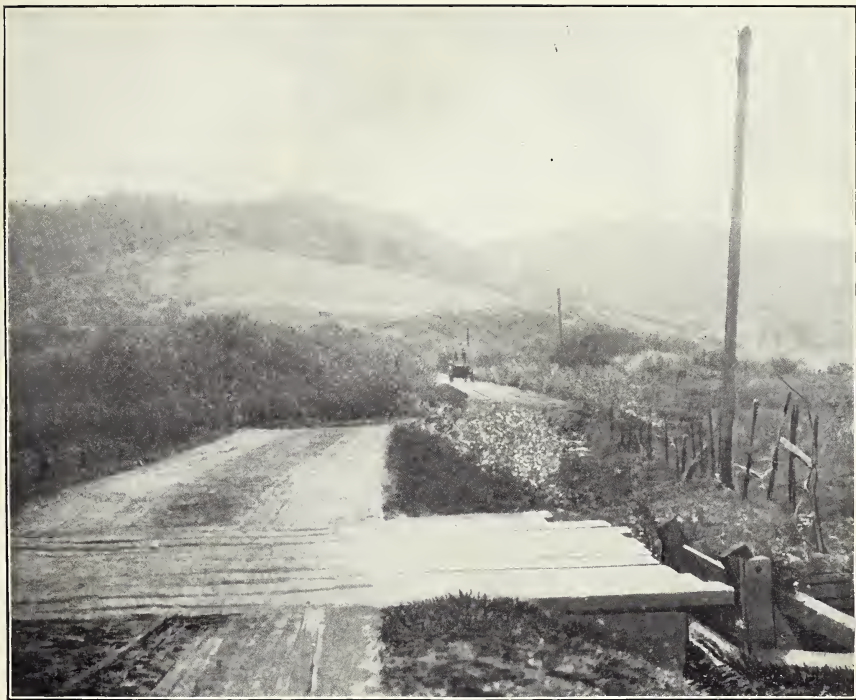
A. ROAD CROSSING FAULT TRACE NEAR POINT REYES STATION.
Looking southwest. Offset, 20 feet. Photograph by G. K. Gilbert.

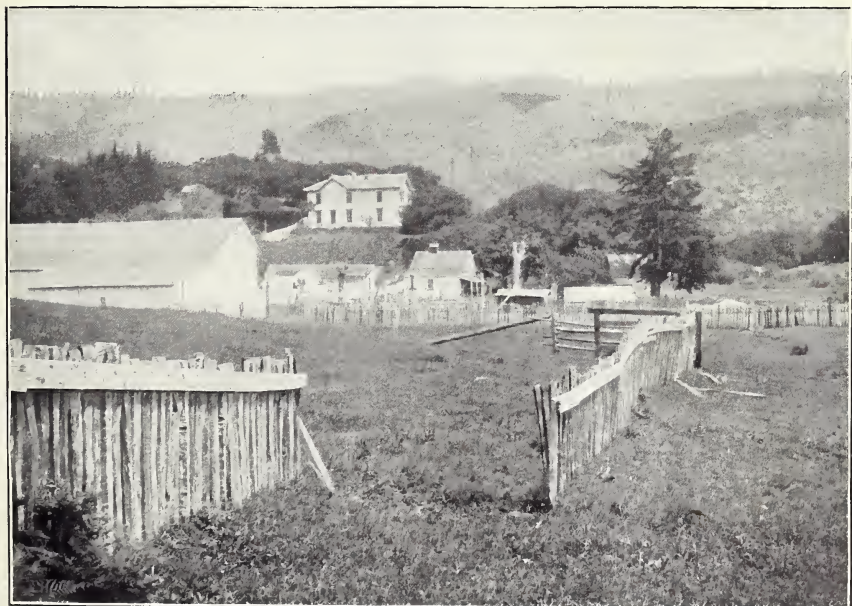
B. FENCE PARTED BY EARTHQUAKE FAULT.

The fault trace or fracture accompanying the earthquake is inconspicuous, although the horizontal displacement is considerable. Photograph by G. K. Gilbert.

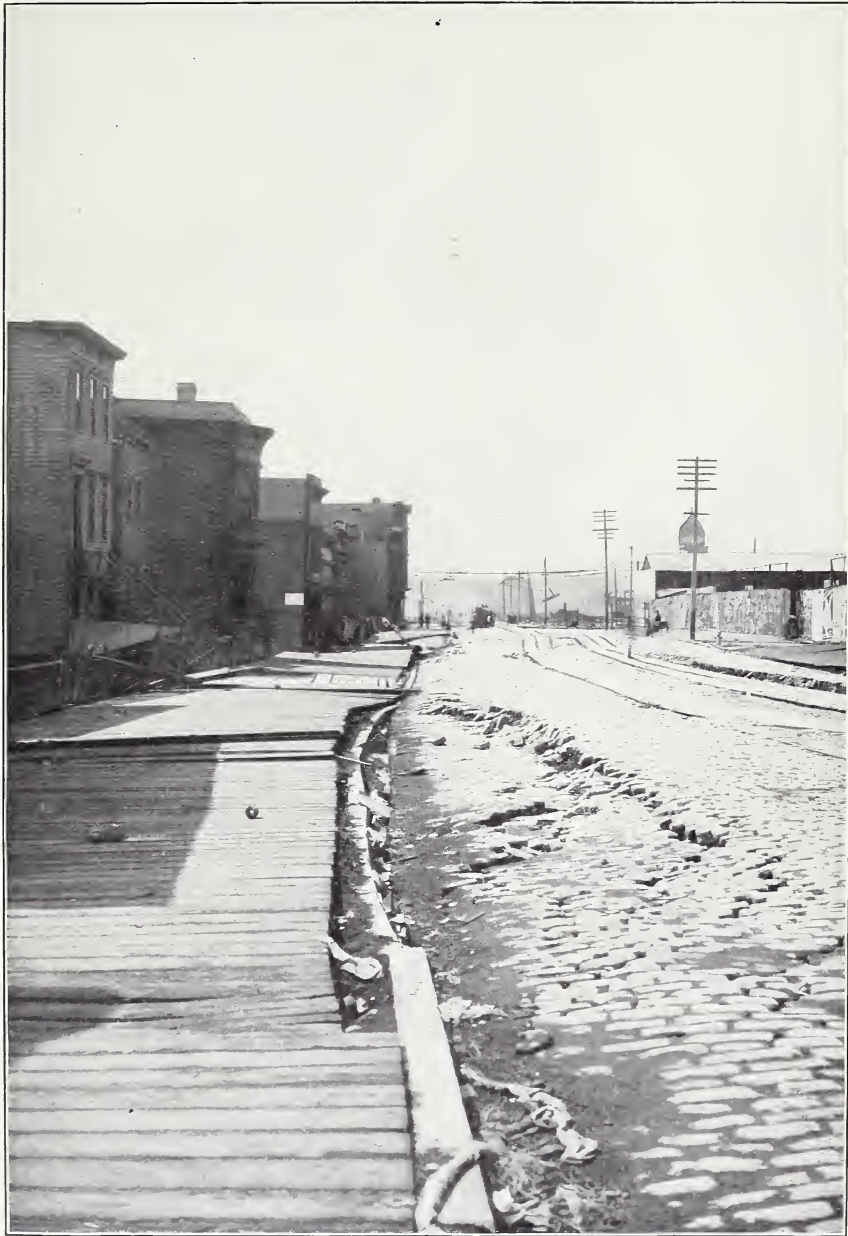
RESULTS OF EARTH FLOW, NINTH STREET, SAN FRANCISCO.

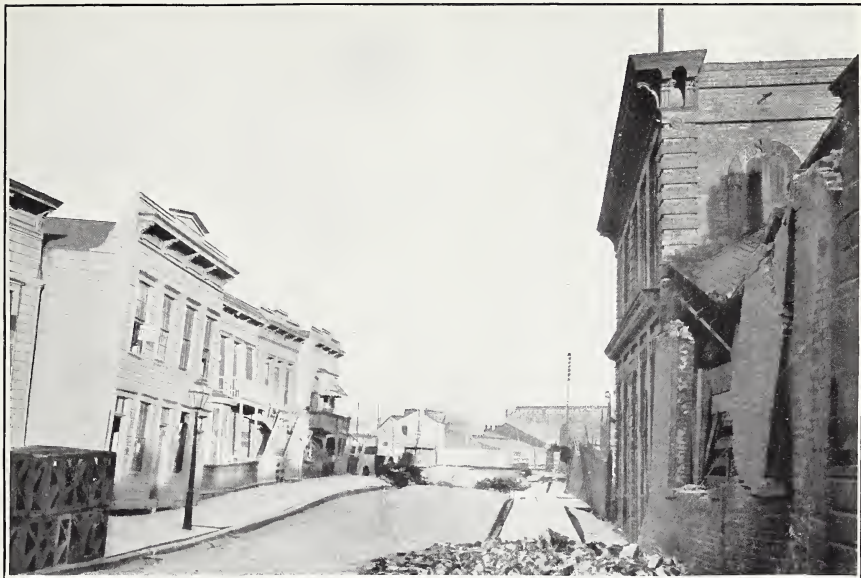
A. SETTLING (5 FEET) ON DORE STREET, BETWEEN BRYANT AND BRANNAN STREETS, SAN FRANCISCO.

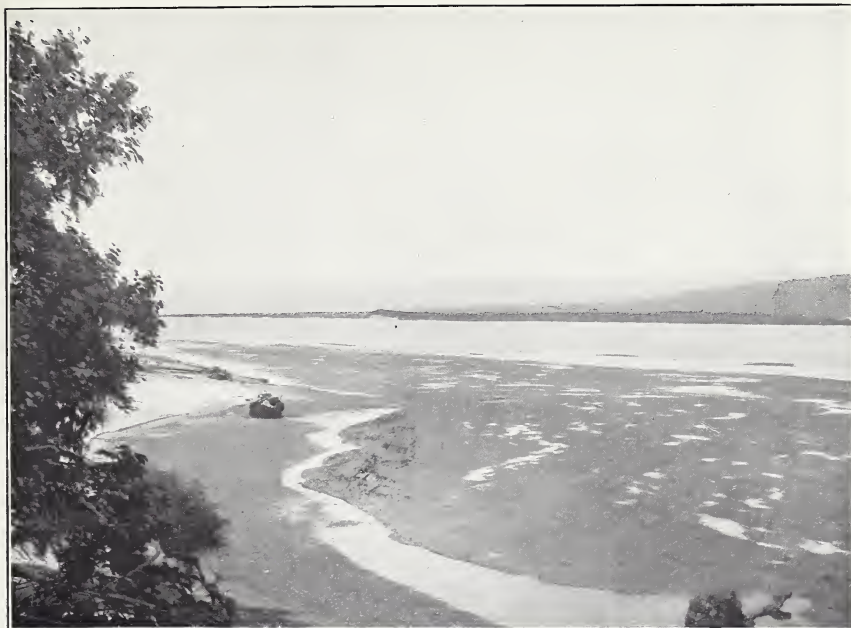
A

SHIFTED BOTTOM OF TOMALES BAY.

A. General view; B, Edge of new shoal. Photographs by G. K. Gilbert.

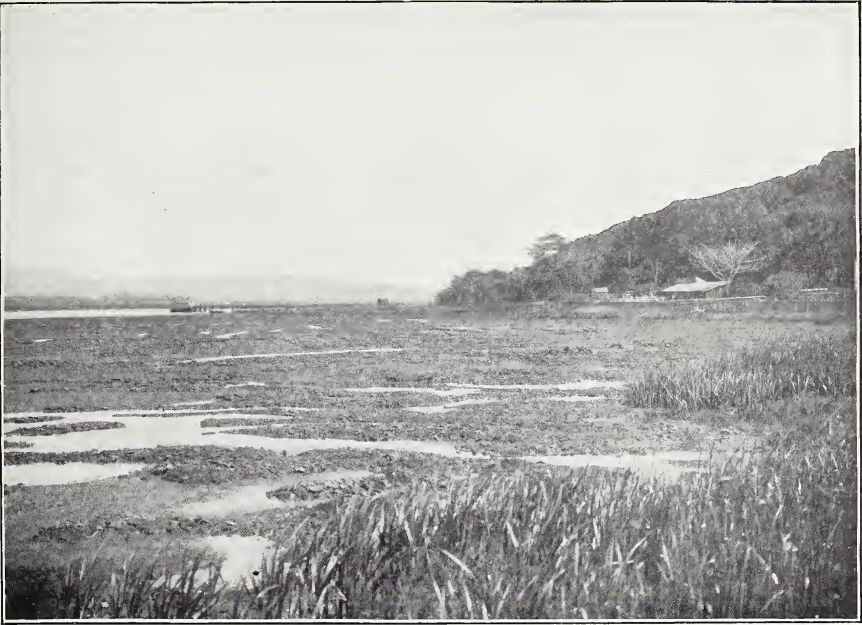
A. EARTHQUAKE RIDGES ON TIDAL FLAT, TOMALES BAY.

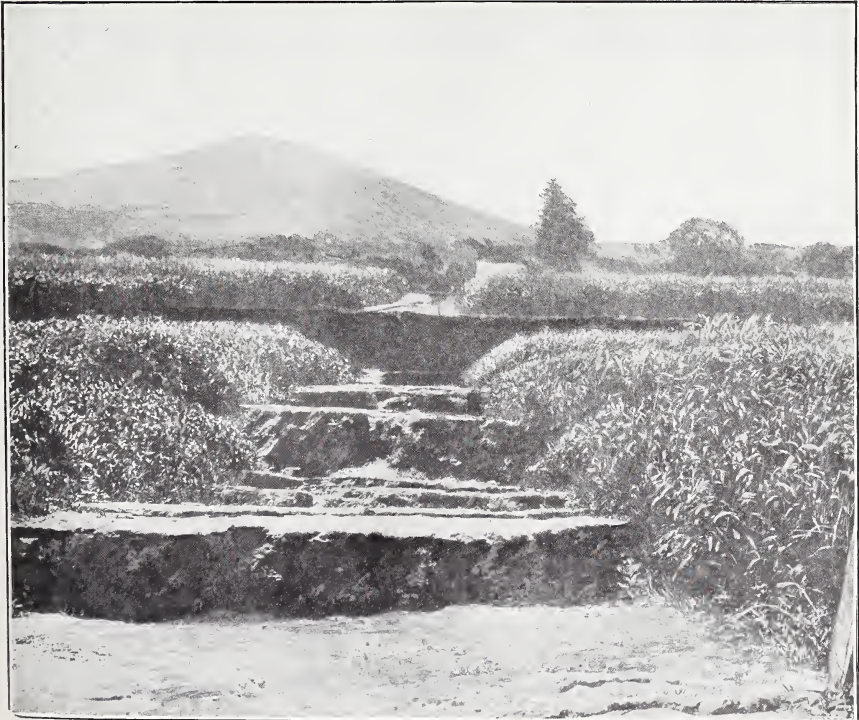
B. SLIPPING OF ALLUVIAL SOIL TOWARD SALINAS RIVER.

Grain field adjoining road along river between Spreckels's sugar mill and Salinas. Photograph by A. C. Lawson.

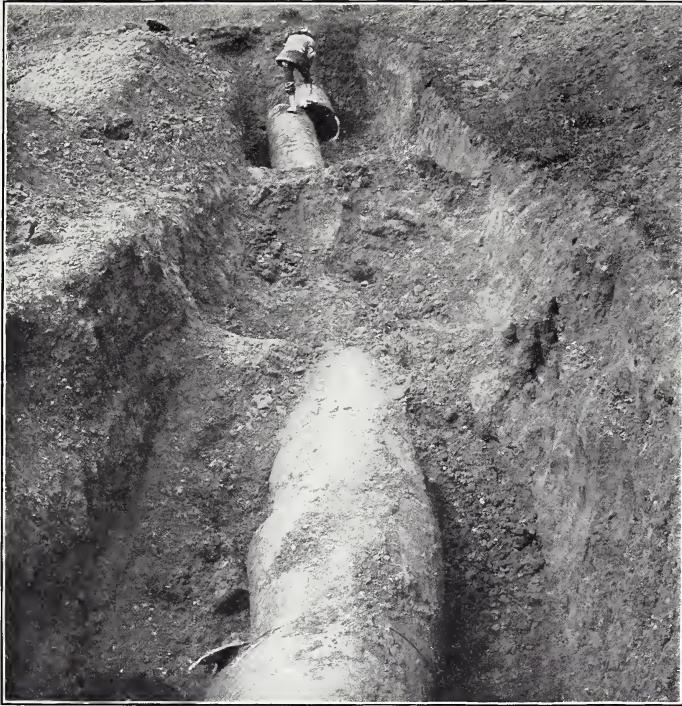
A

DAMAGE TO PILARCITOS 30-INCH PIPE LINE BY EARTHQUAKE.

A, Offset; *B*, Telescoping. Photographs submitted by Frank Soulé.

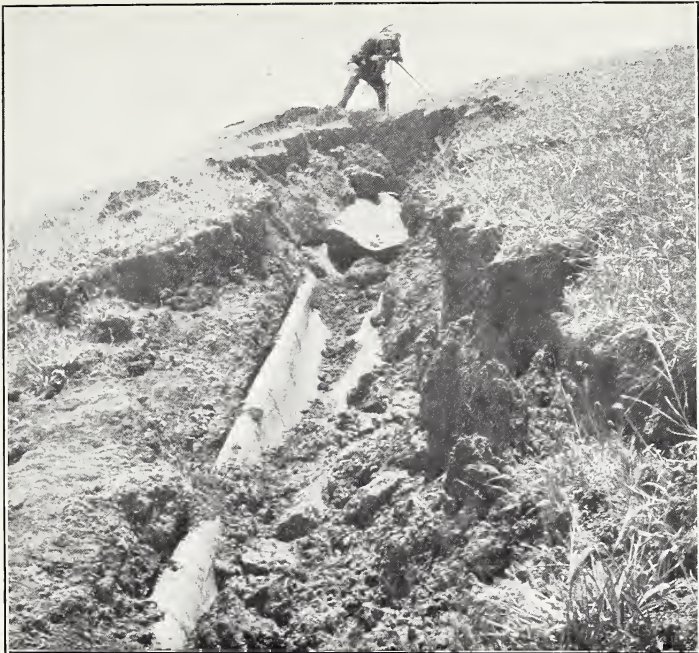
A. COLLAPSED PILARCITOS 30-INCH WROUGHT-IRON PIPE LINE, NEAR
TRESTLE CROSSING THE FAULT.

The slip produced a compression on the pipe line which buckled it, thereby throwing down the trestle support. The consequent parting of the pipe line suddenly released the water from the pipe, causing a vacuum which brought about the collapse. Photograph by Richard L. Humphrey.

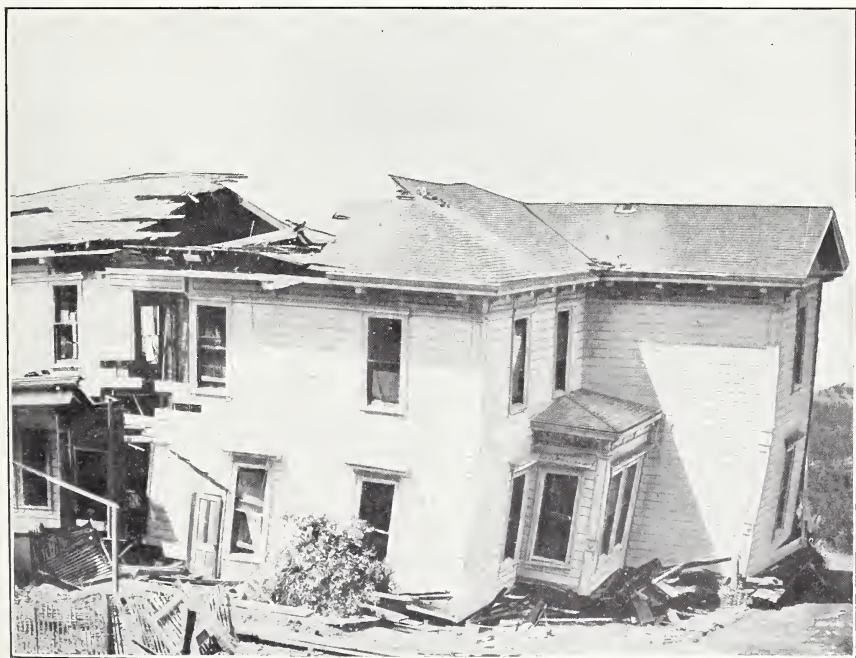
B. HOUSE ON LINE OF FAULT, TORN ASUNDER BY EARTHQUAKE.

Near Wrights Station, on Southern Pacific Railroad. Photograph by Richard L. Humphrey.

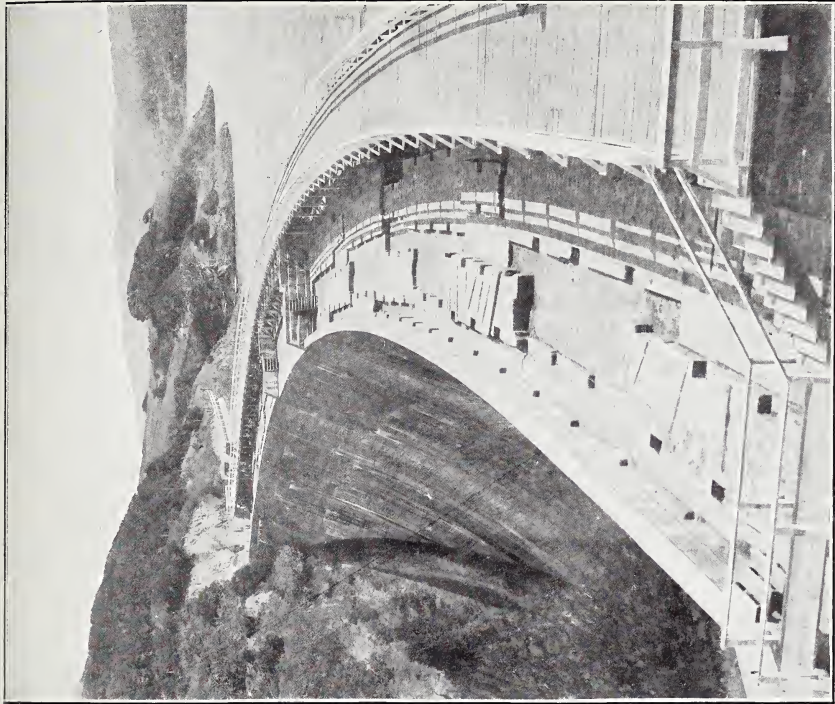
7. ENDURANCE OF CONCRETE DAM NEAR FAULT TRACE, AT CRYSTAL SPRINGS LAKE, SAN MATEO. Photograph by Richard L. Humphrey.

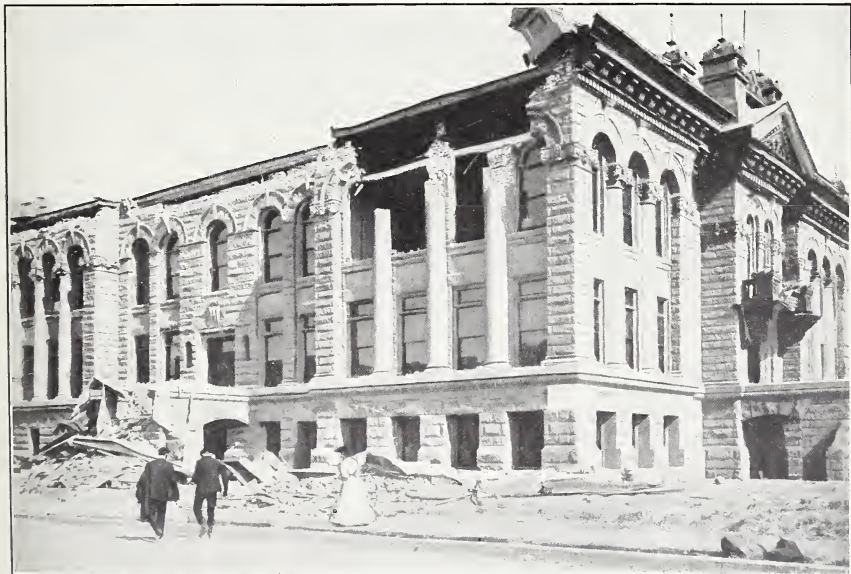
B. EARTHQUAKE WRECK OF NEW HALL OF JUSTICE, SAN JOSE, BUILT ON ALLUVIAL SOIL.

Wreck due to poor quality of stonework and unnecessarily massive construction. Photograph by Frank Soulé.

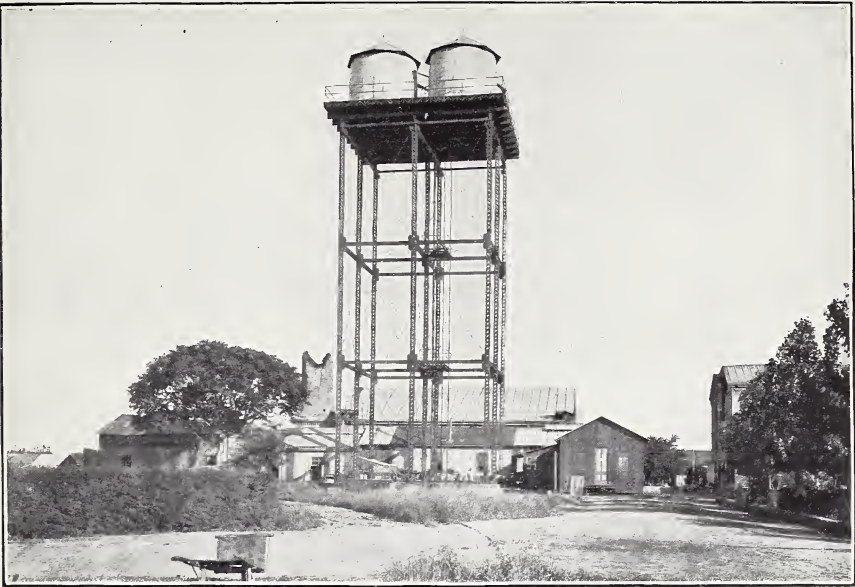
A. COMPARATIVE EARTHQUAKE ENDURANCE OF DISSIMILAR STRUCTURES, AGNEW INSANE ASYLUM, NEAR SAN JOSE.

Tanks on steel trestle, undamaged, and circular brick stack, collapsed. Photograph by Richard L. Humphrey.

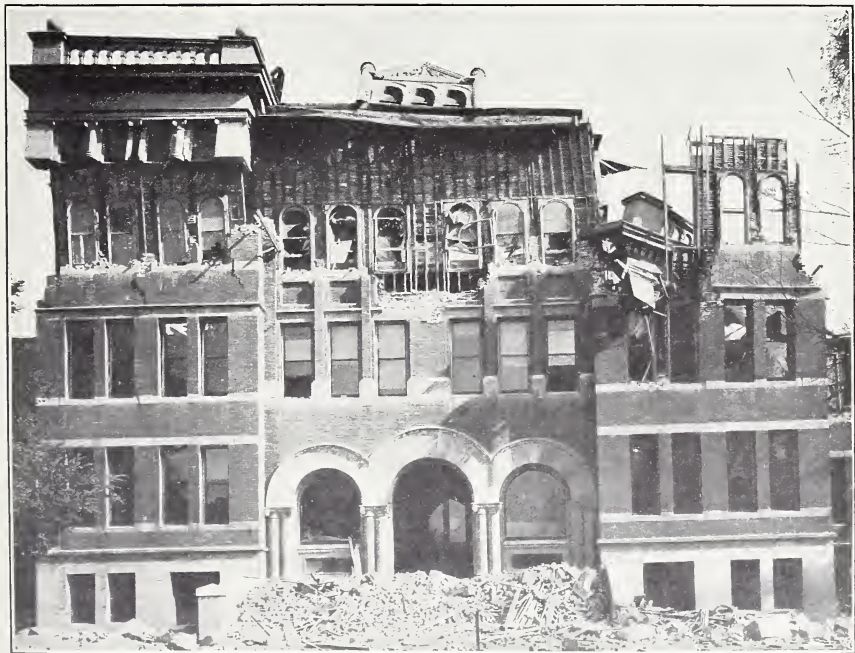
B. EARTHQUAKE EFFECT, HIGH SCHOOL BUILDING, SAN JOSE.

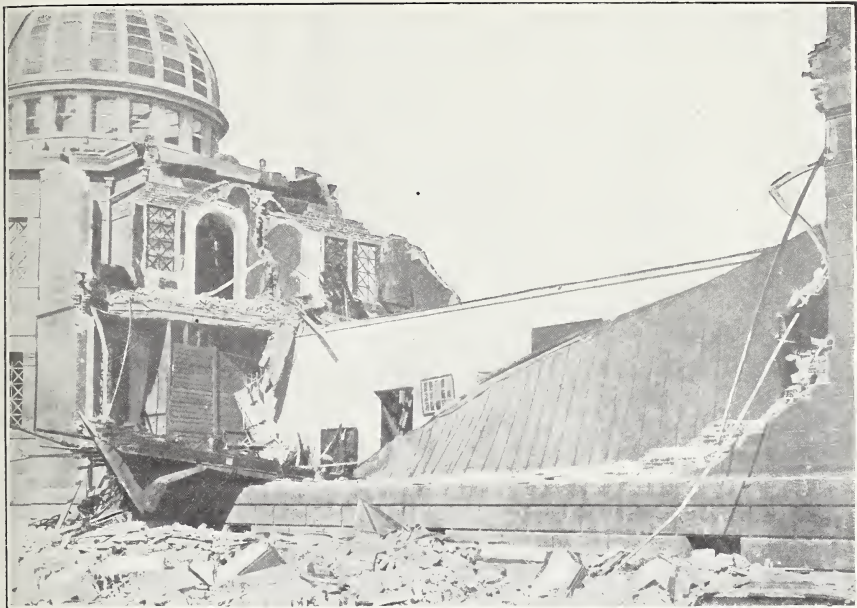
A. COMPARATIVE BEHAVIOR OF REENFORCED CONCRETE AND BRICKWORK UNDER EARTHQUAKE VIBRATION, MUSEUM, LELAND STANFORD JUNIOR UNIVERSITY.

The central portion, of reinforced concrete, was undamaged, but the brick wings collapsed. Photograph by Richard L. Humphrey.

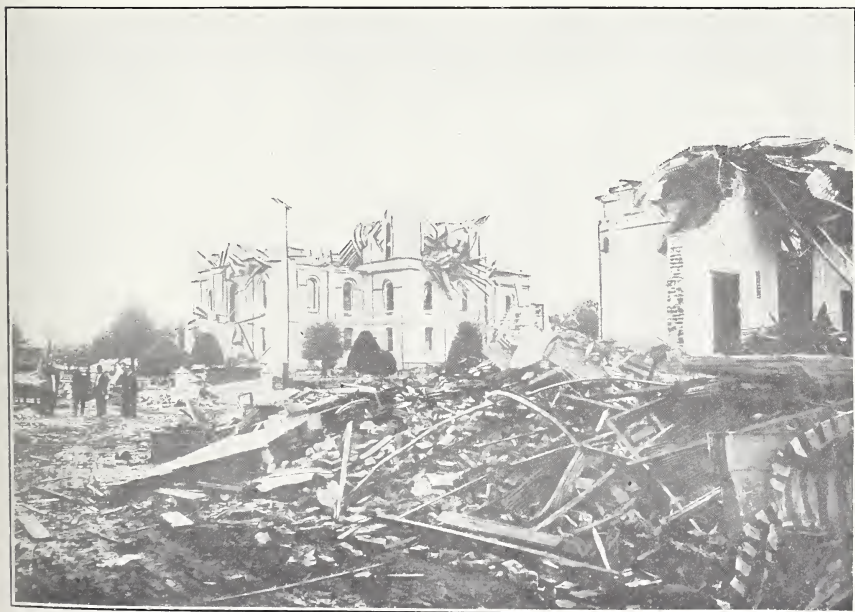
B. COMPLETE WRECK BY EARTHQUAKE, COURT-HOUSE AND HALL OF RECORDS, SANTA ROSA.

Wreck due to light wooden framing, insufficient bracing, and poor mortar. Photograph submitted by Richard L. Humphrey.

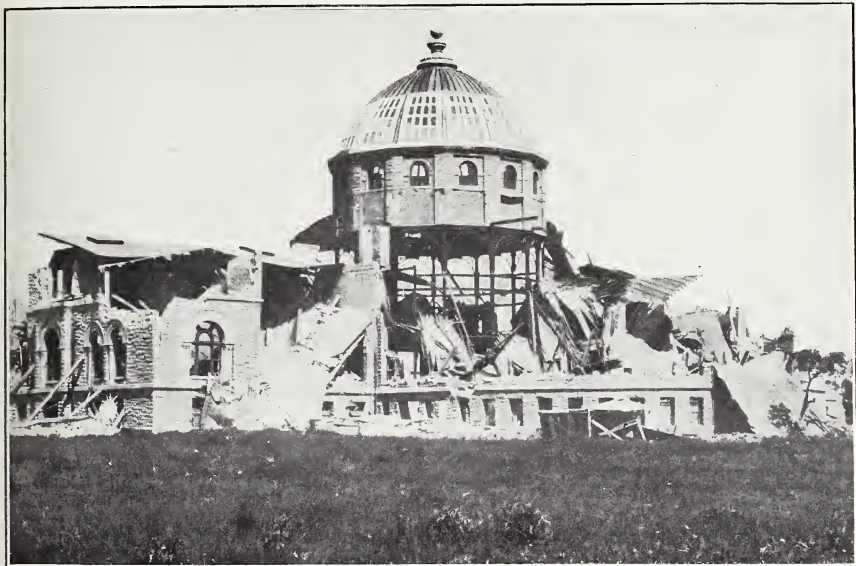
A. UNDAMAGED STEEL FRAMEWORK SUPPORTING DOME OF LIBRARY.

ENDURANCE OF STEEL FRAMEWORK AS AFFECTED BY METHOD OF SUPPORT, LELAND STANFORD JUNIOR UNIVERSITY.

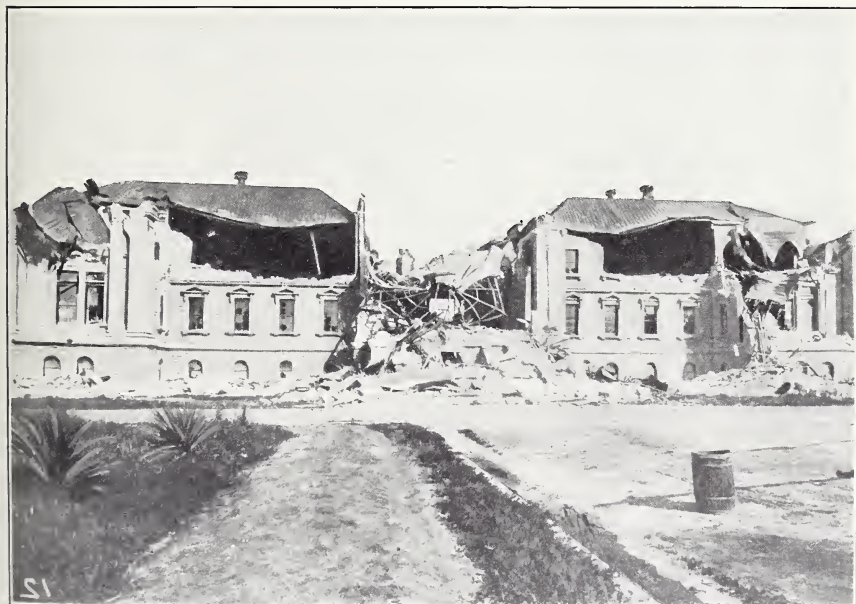
B. COLLAPSE OF BRICK WALLS, CAUSING DESTRUCTION OF STEEL SKELETON DOME OF GYMNASIUM.

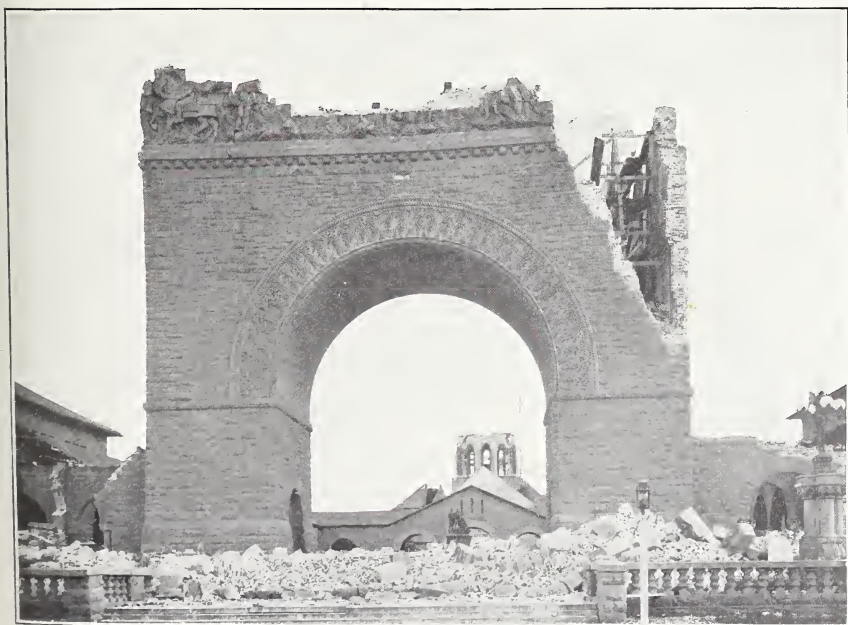
B

MEMORIAL ARCH, LELAND STANFORD JUNIOR UNIVERSITY.

A, Before the earthquake (photograph submitted by Richard L. Humphrey); B, Earthquake effect (photograph by Richard L. Humphrey). The beams designed to stiffen the walls were not tied to them and helped to batter them down when the shock came.

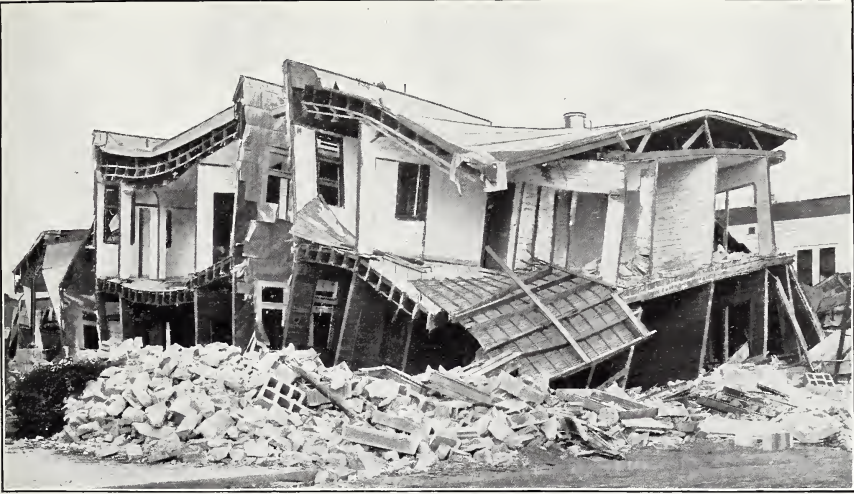
J. COLLAPSE DUE TO LACK OF TIE BETWEEN WALLS AND FRAME, THIELE BUILDING (CEMENT BLOCK), PALO ALTO.

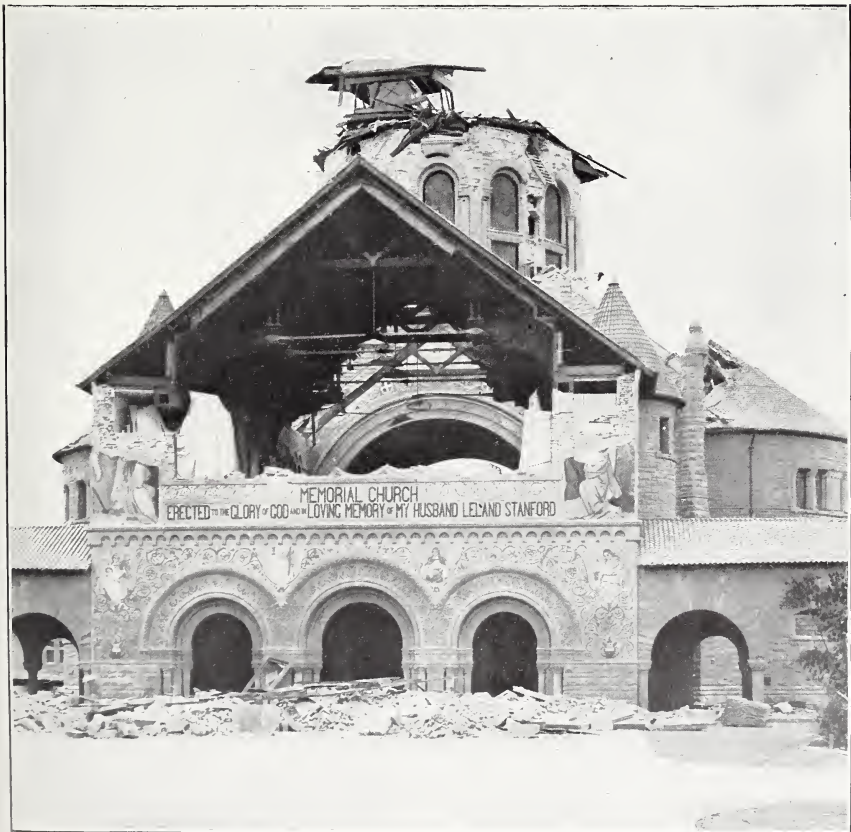
J. COLLAPSED TOWER AND GENERAL EARTHQUAKE WRECKAGE, MEMORIAL CHURCH, LELAND STANFORD JUNIOR UNIVERSITY.

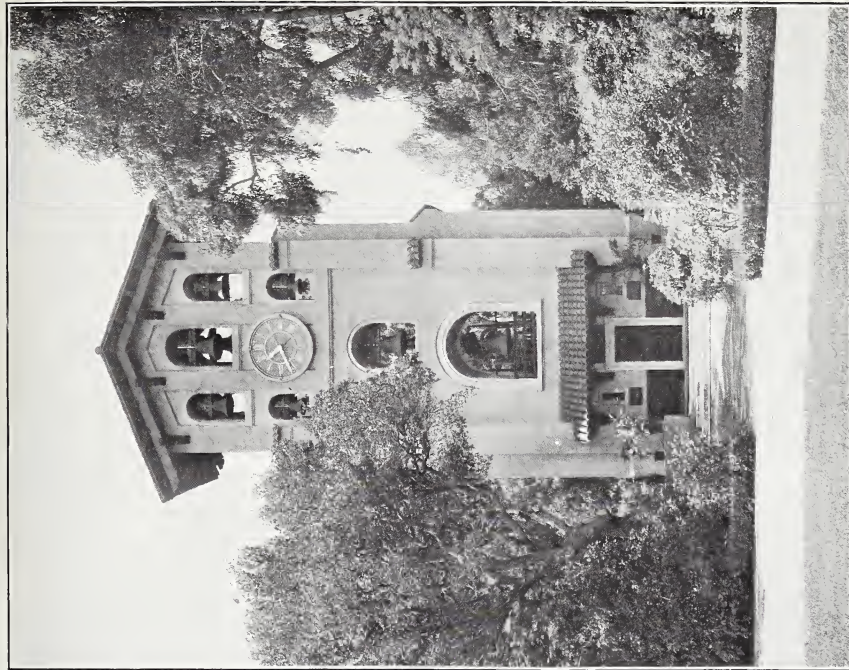
7. UNDATED REINFORCED-CONCRETE STRUCTURE AT MILLS COLLEGE, NEAR OAKLAND.

Bell tower, within a few feet of a brick building that was badly racked by the earthquake. Photograph by Richard L. Humphrey.

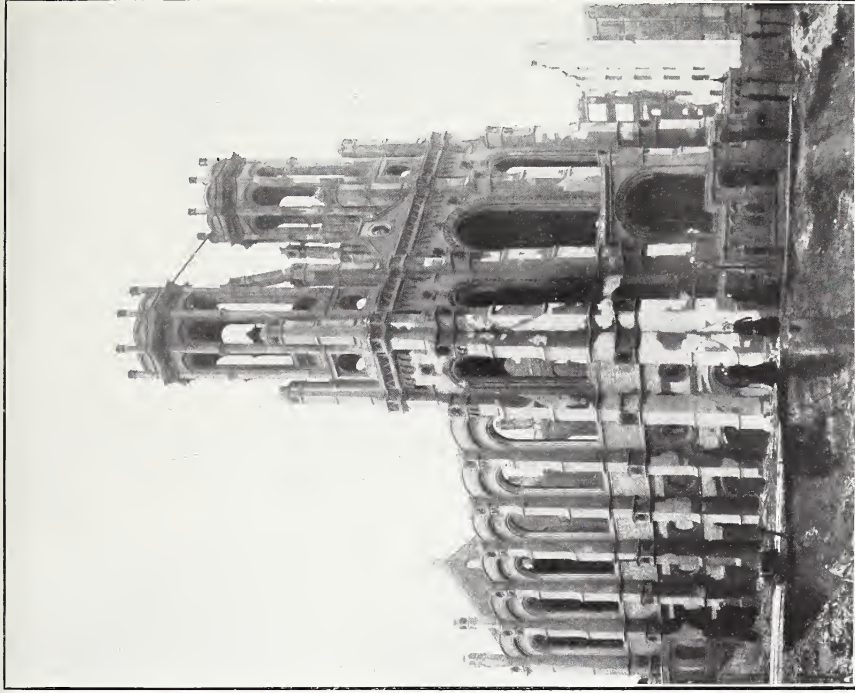
7. GOOD EARTHQUAKE ENDURANCE OF BUTTRESSED WALLS, SYNAGOGUE EMANUEL, SAN FRANCISCO.

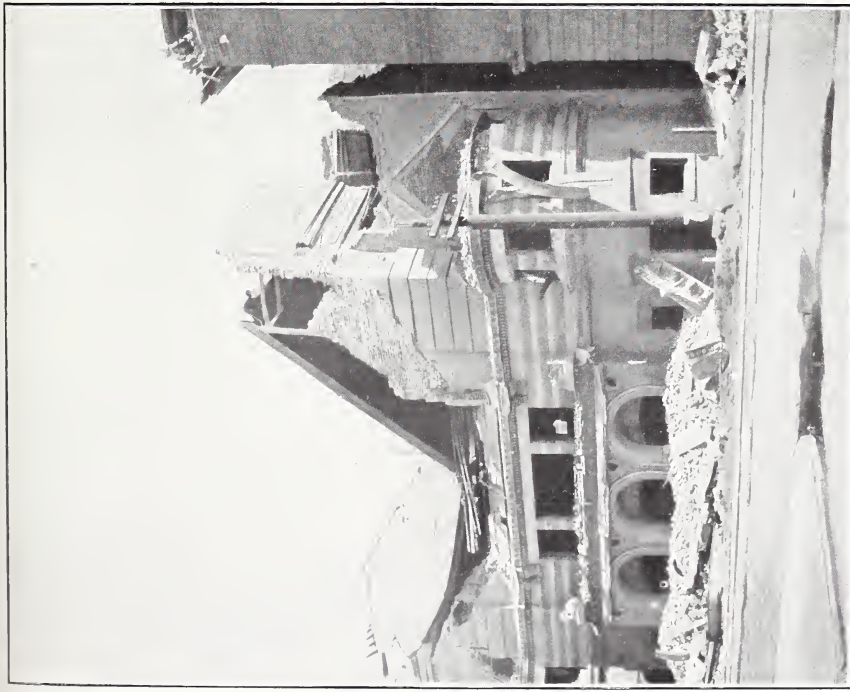
4. RACKING OF NEWLY CONSTRUCTED BUILDING, SYNAGOGUE, GEARY AND FILLMORE STREETS, SAN FRANCISCO.

Note the separation of the brick veneer from the backing; also the racking of the wall at the corner. Photograph by John Stephen Sewell.

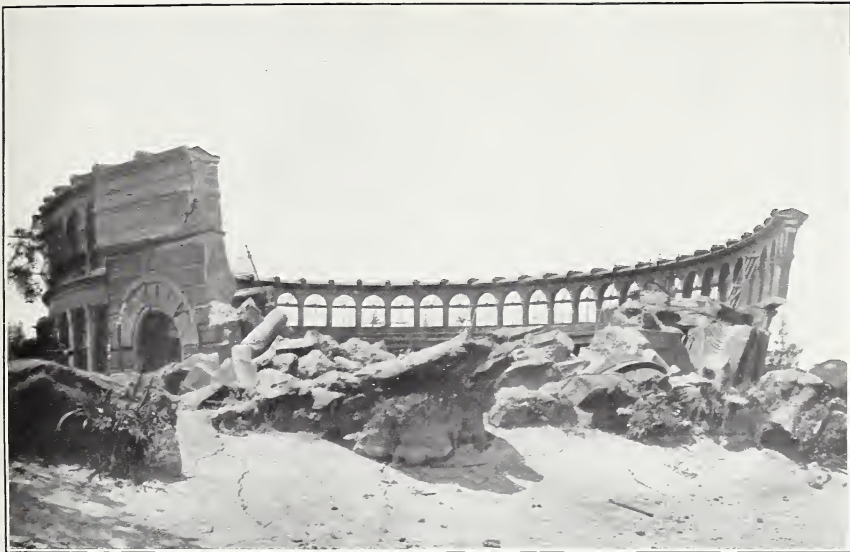
A. EARTHQUAKE EFFECT ON STRUCTURE OF REINFORCED CONCRETE OF POOR QUALITY.
Cyclorama, Strawberry Hill, Golden Gate Park, San Francisco. Photograph by Richard L. Humphrey.

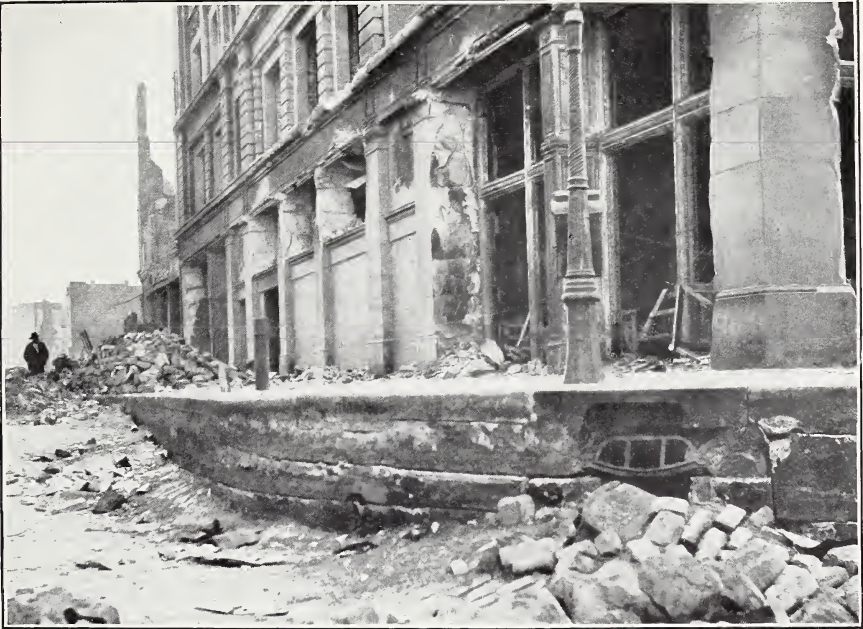
A. SUBSIDENCE OF STREET IN FRONT OF ÆTNA BUILDING. SAN FRANCISCO.

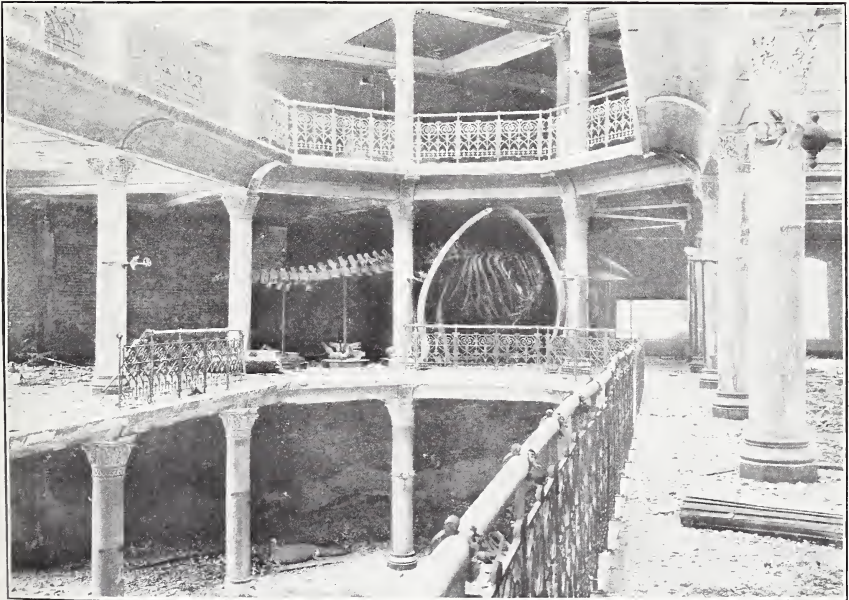
B. FIRE ENDURANCE OF CONCRETE, ANNEX OF ACADEMY OF SCIENCES BUILDING, SAN FRANCISCO.

Reinforced-concrete floors and concrete-filled cast-iron columns with plaster covering. Photograph by Richard L. Humphrey.

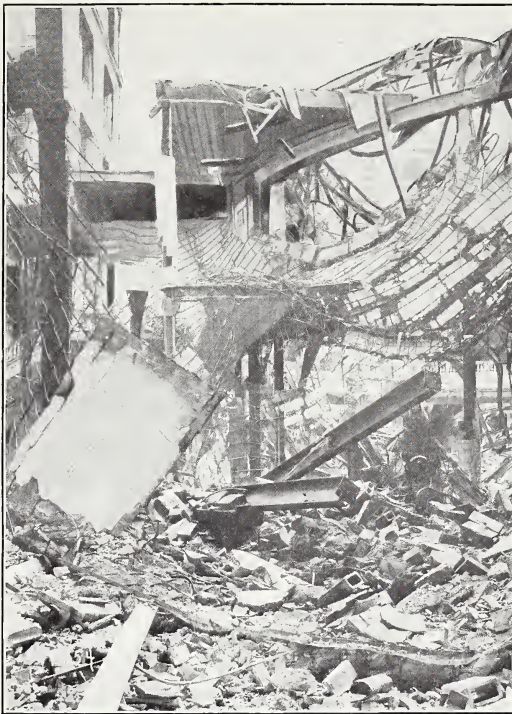
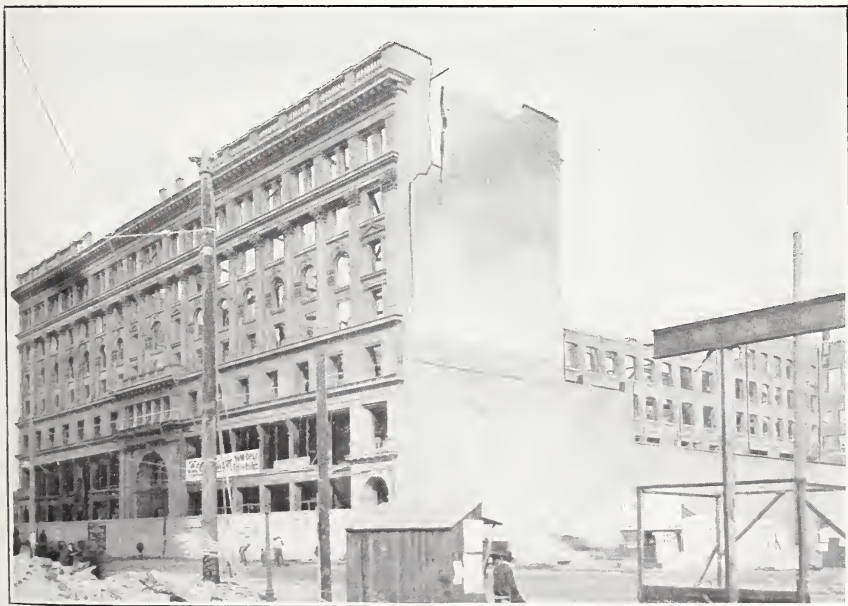
COMPLETE FAILURE OF SLOW-BURNING WOOD CONSTRUCTION,
THE EMPORIUM, SAN FRANCISCO.

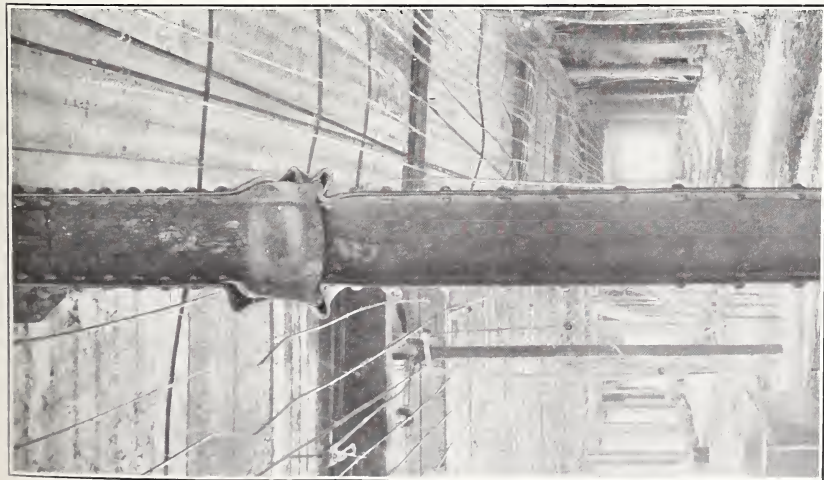
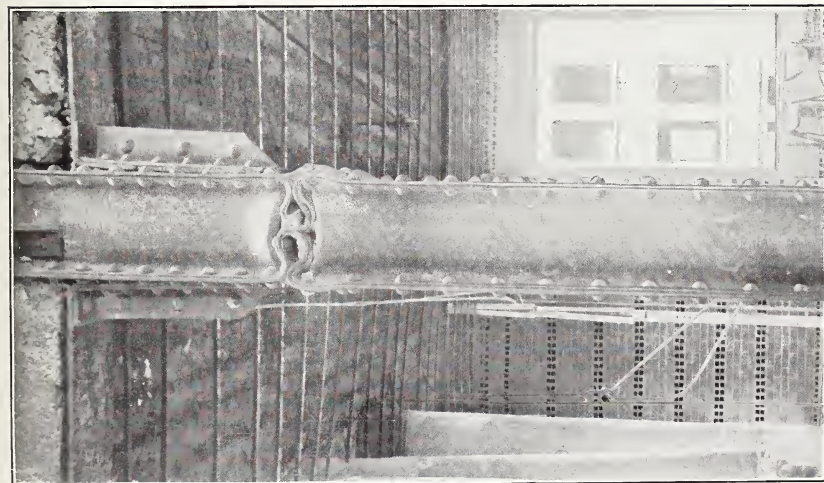
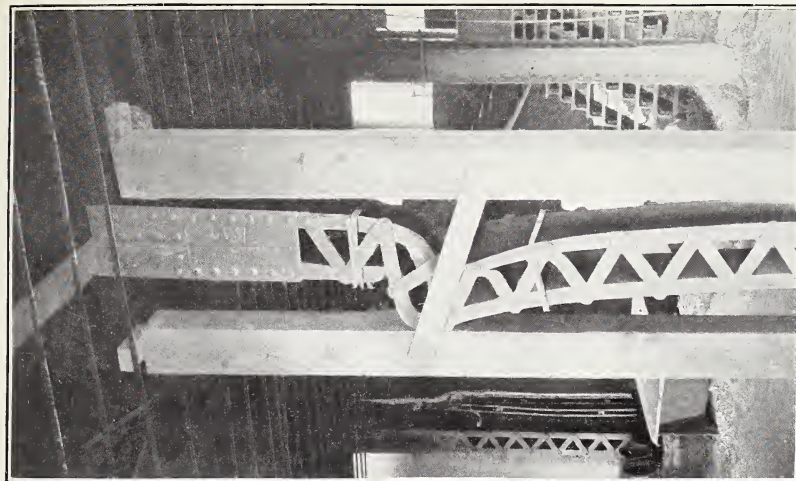
BUCKLING OF COLUMNS DUE TO FAILURE OF PLASTERED METAL-LATH FIREPROOFING, FAIRMOUNT HOTEL, SAN FRANCISCO.

The method of fireproofing was to inclose the column between the metal lath forming the partitions. Photographs by Richard L. Humphrey.

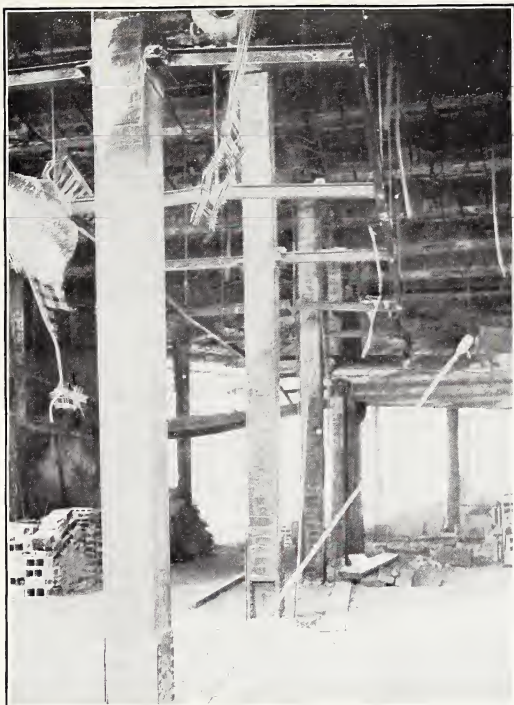
A. INCipient BUCKLING OF COLUMNS FROM HEAT, FIRST STORY, JAMES FLOOD BUILDING, SAN FRANCISCO.

The brick filling probably saved the columns from fatal buckling or collapse. Photograph by John Stephen Sewell.

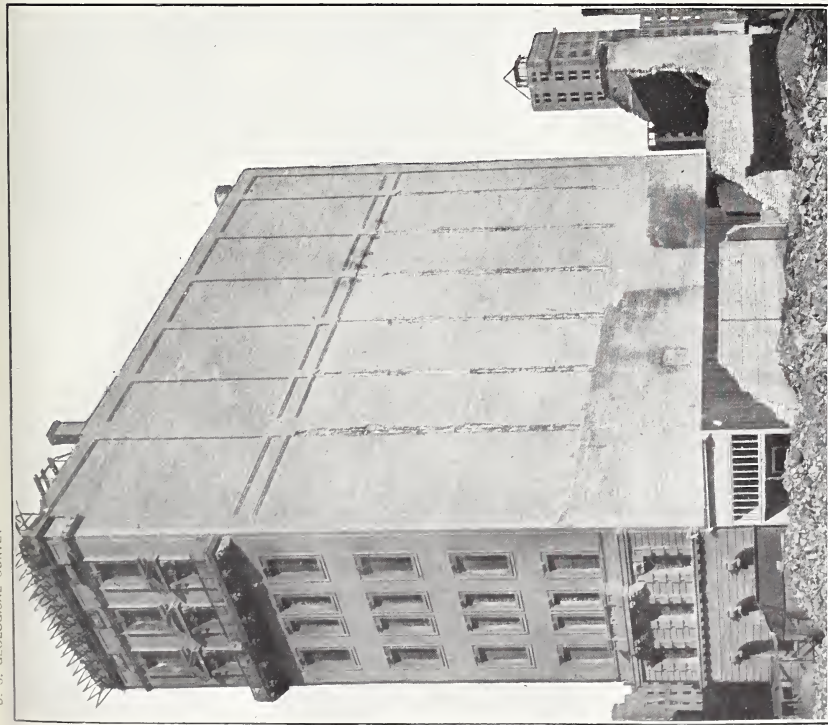
A. ENDURANCE OF A WELL-PROTECTED BUILDING SUBJECTED TO SEVERE HEAT, MAIN EXCHANGE OF PACIFIC STATES TELEPHONE AND TELEGRAPH COMPANY, SAN FRANCISCO.
 Rolling shutters, self-supporting brick walls, concrete floors, and concrete protection for columns and girders. Photograph by Richard L. Humphrey.

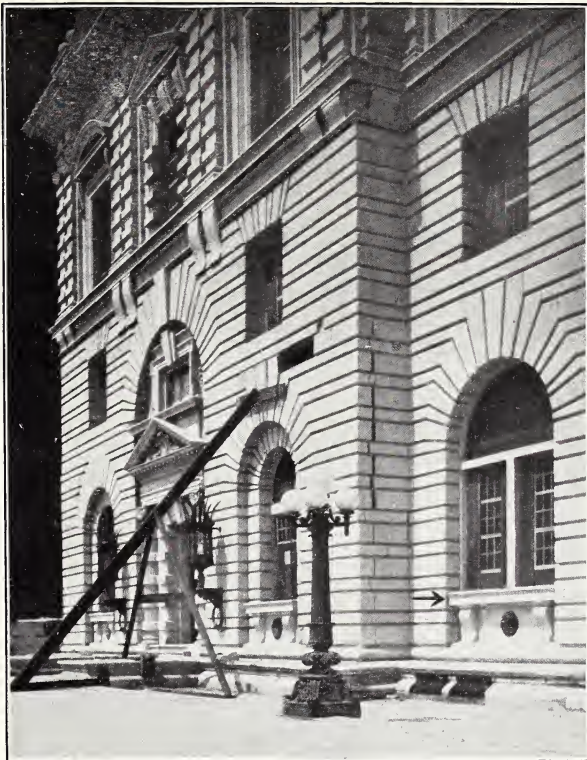
A. CRACKS IN MASONRY, PAVILION OF POST-OFFICE, SAN FRANCISCO.

The window reveal and sill were jostled together by the earthquake at the point indicated by the arrow. Photograph by John Stephen Sewell.

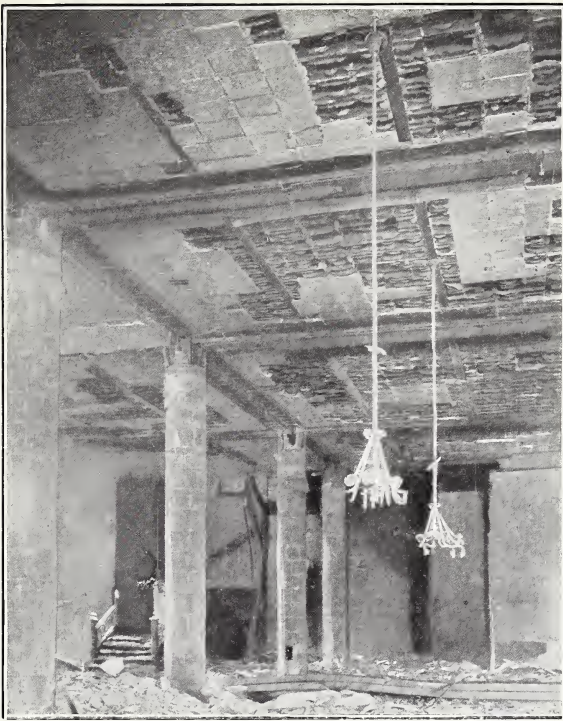
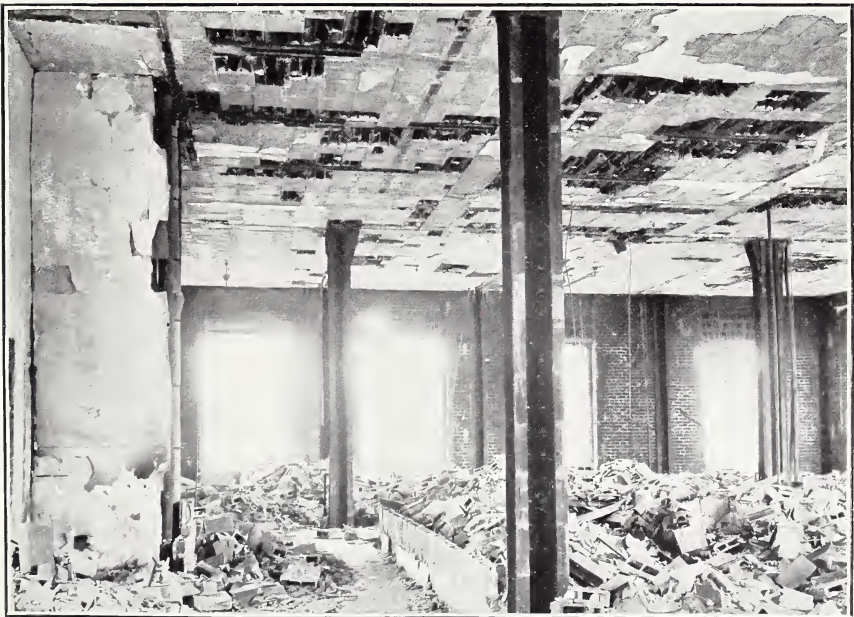
FAILURE OF HOLLOW TERRA-COTTA TILE FIREPROOFING.

A, First story of Spring Valley Water Company's Building, San Francisco (photograph by John Stephen Sewell);
B, Mills Building, San Francisco (photograph by Richard L. Humphrey). The lower webs of the floor tiles
were spalled or taken entirely off by the fire.

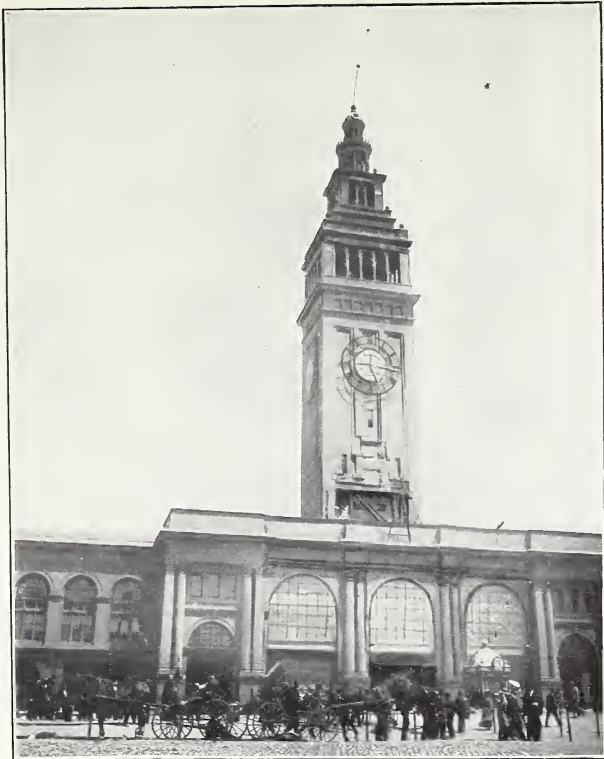
A. BRICKWORK THROWN DOWN BY EARTHQUAKE VIBRATION,
TOWER OF UNION FERRY BUILDING, SAN FRANCISCO.

Note bending of time-ball shaft. Photograph submitted by Richard L.
Humphrey.

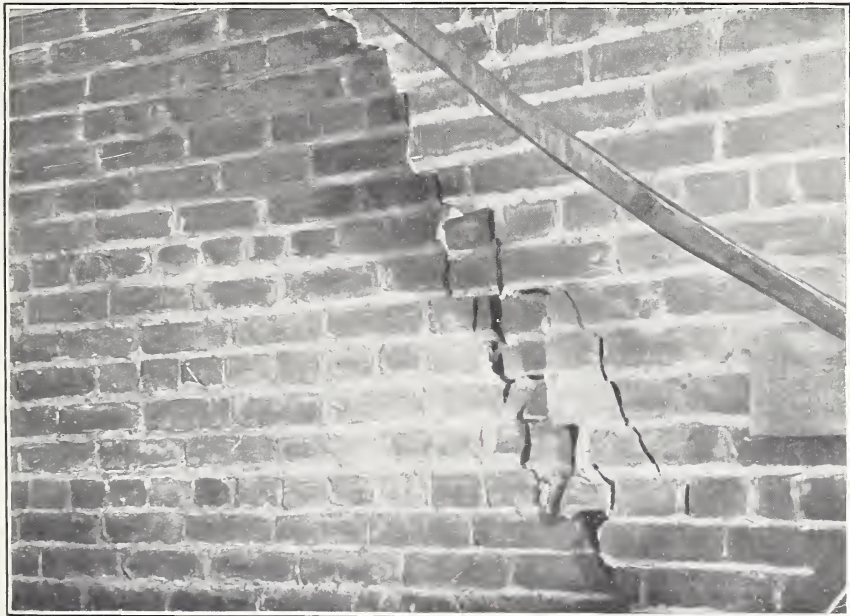
B. EFFECT OF SEVERE SHAKING ON WELL-BONDED BRICKWORK FILLED WITH GOOD
MORTAR, TOWER OF UNION FERRY BUILDING.

Note sagged tie-rod, stretched by the racking of the structure. Photograph by John Stephen Sewell.

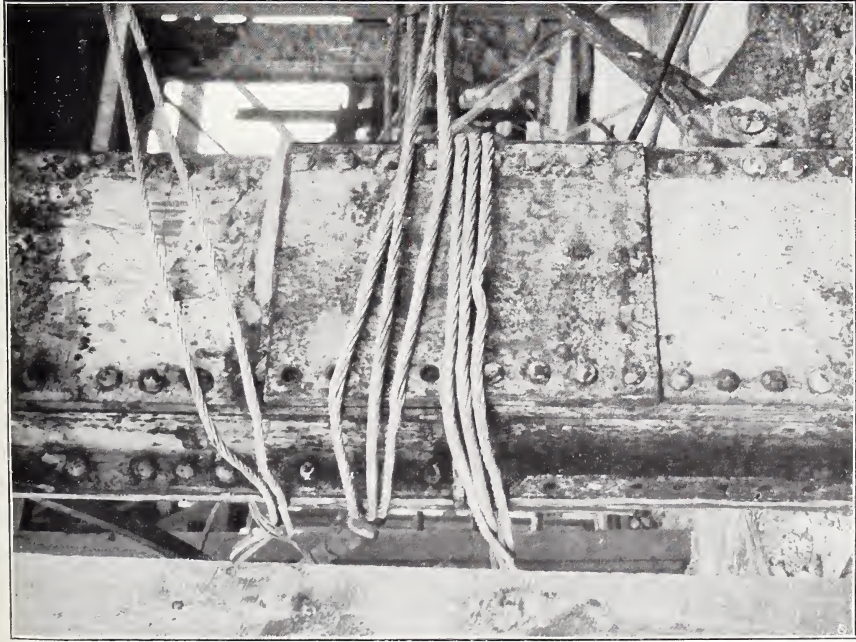
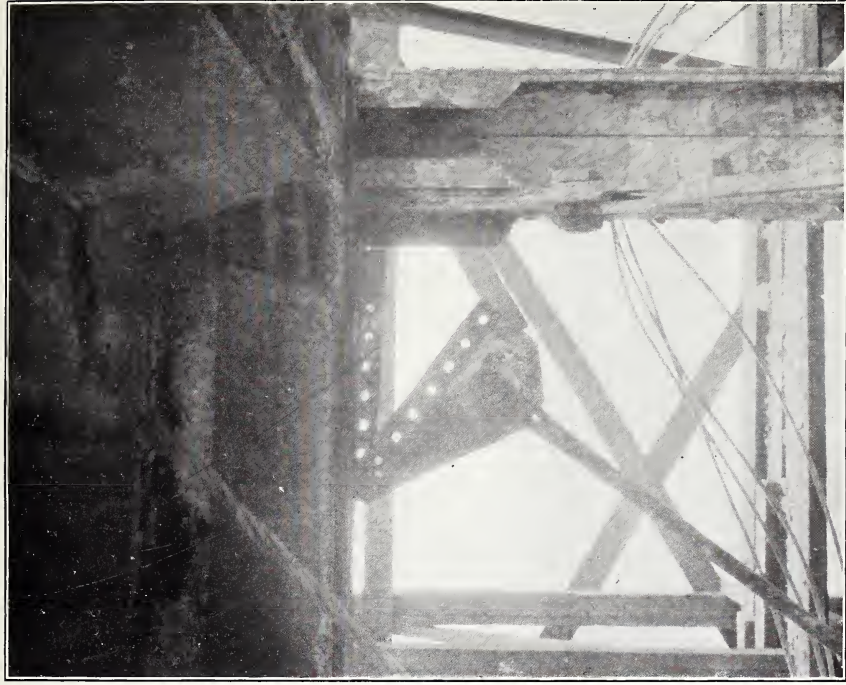
SHEARED RIVETS, TOWER OF UNION FERRY BUILDING, SAN FRANCISCO.

A, In column cover plate; B, In diagonal connection. Photographs by Richard L. Humphrey.
